# **Weatherization is Sexy**

**Claire Betze & Jon Riley**

# Case Study

# Island Farm House

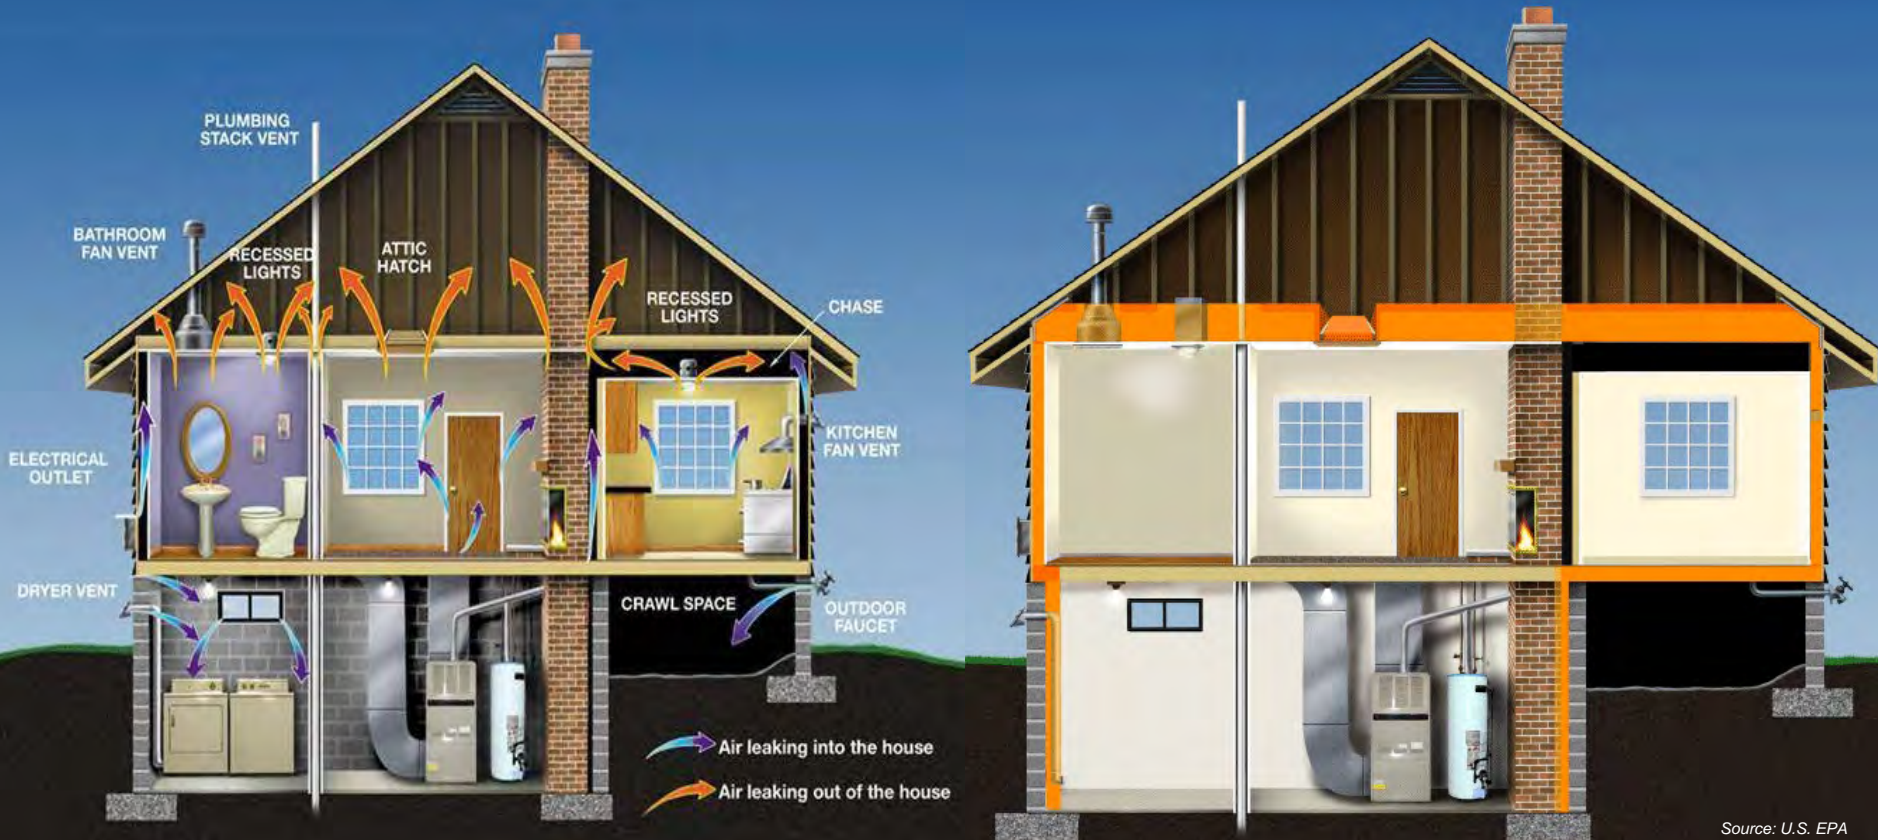
# Pre and Post Weatherization Envelope

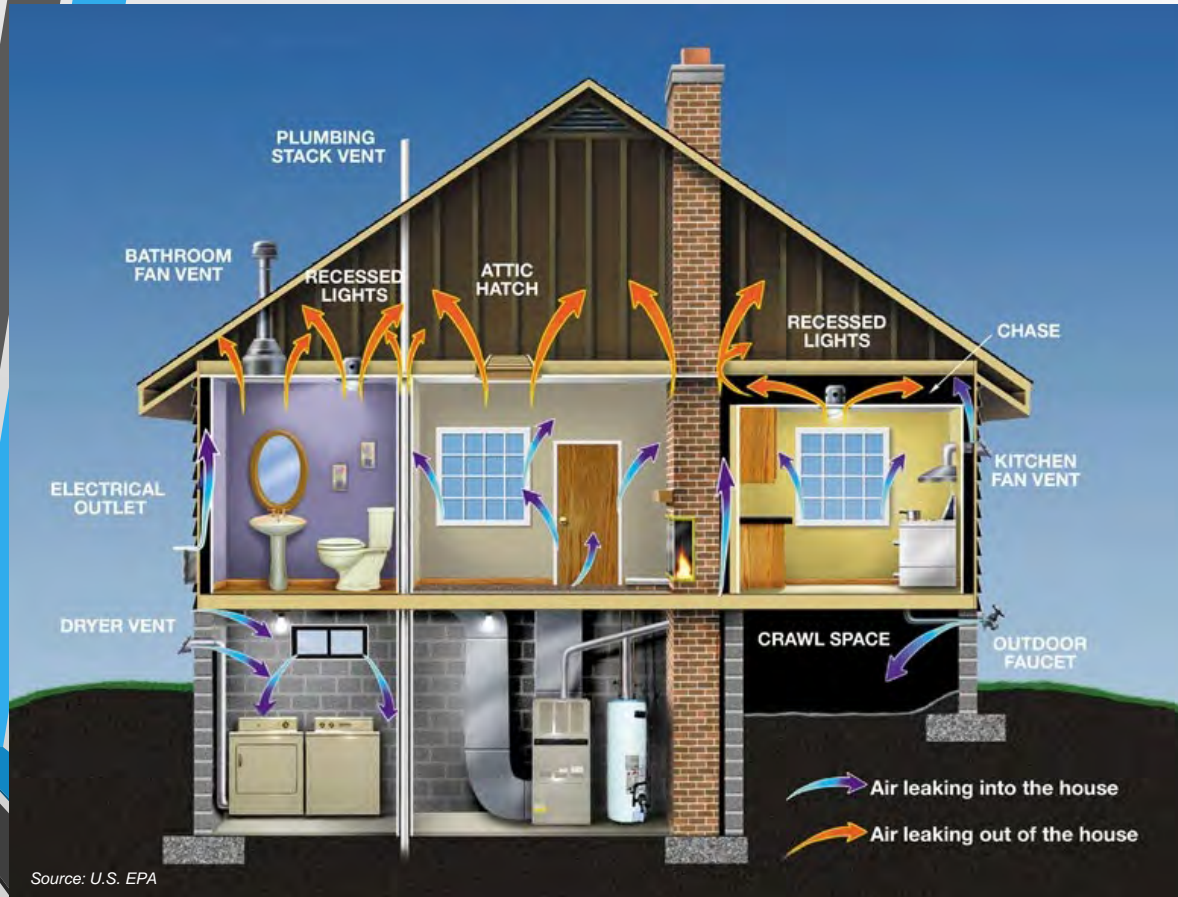
“Stack Effect”

The heated air inside the home is naturally buoyant and puts pressure on the upper envelope of the home

The positive pressure forces the heated air out through gaps and cracks in the pressure barrier.

For every cubic foot of heated air that leaves through the top, a cubic foot of cold, unconditioned air must enter from below

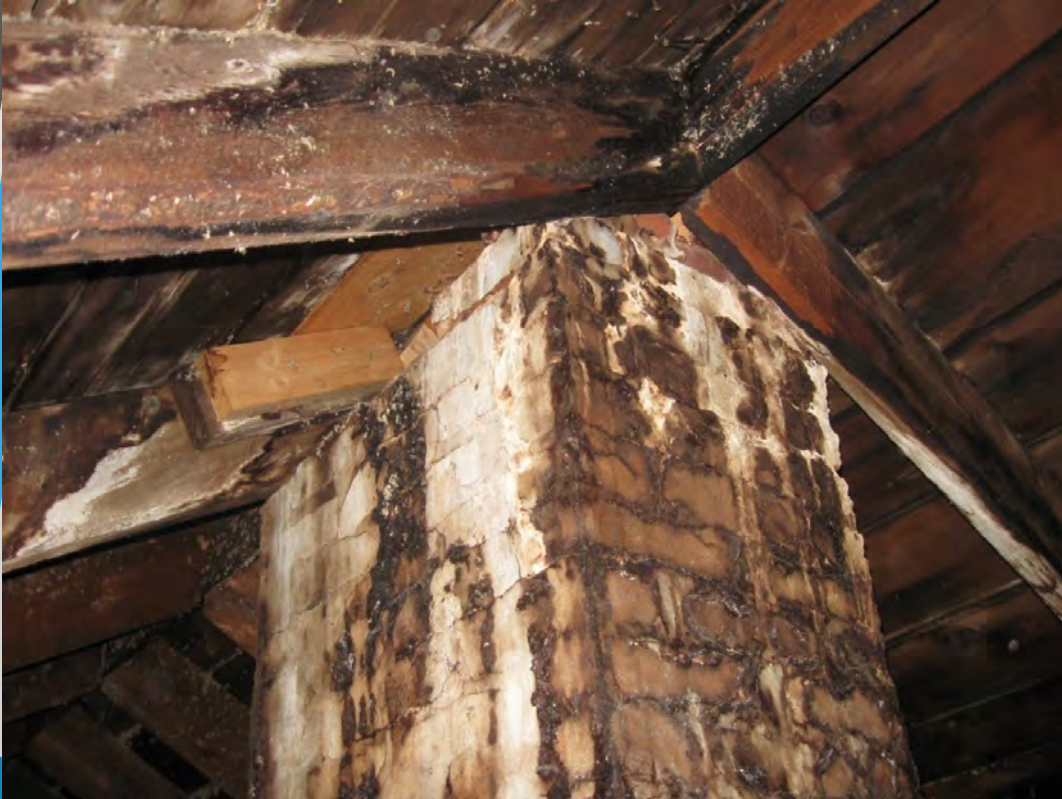
**Basement moisture?**

**Improperly vented bath fans?**

**Flashing or roof failure?**

**Insufficient attic venting?**

**Unlined chimney?**

**All of the above.**

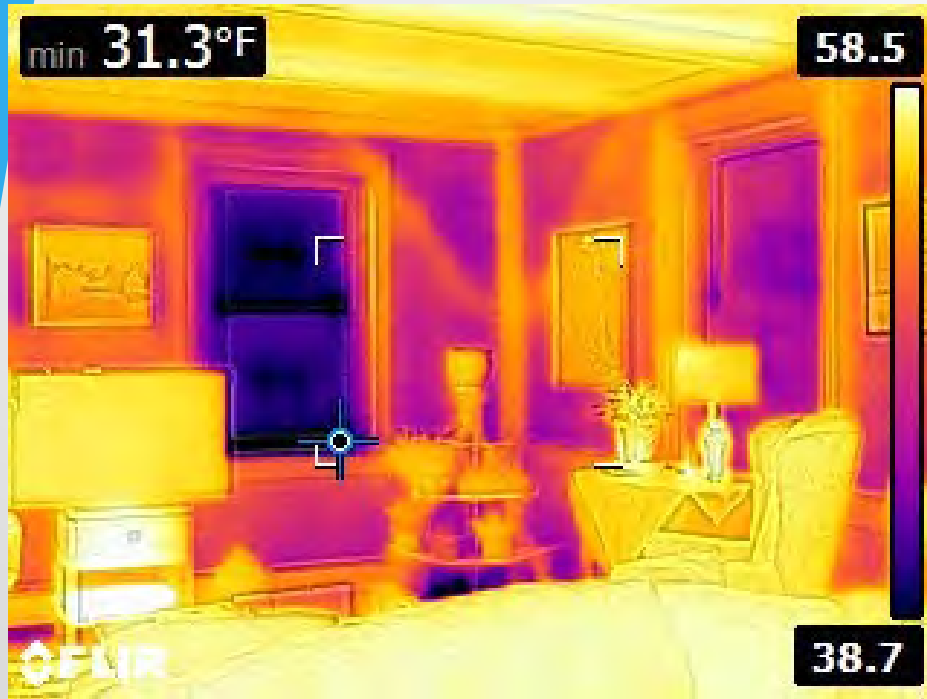
No insulation in the exterior wall assembly

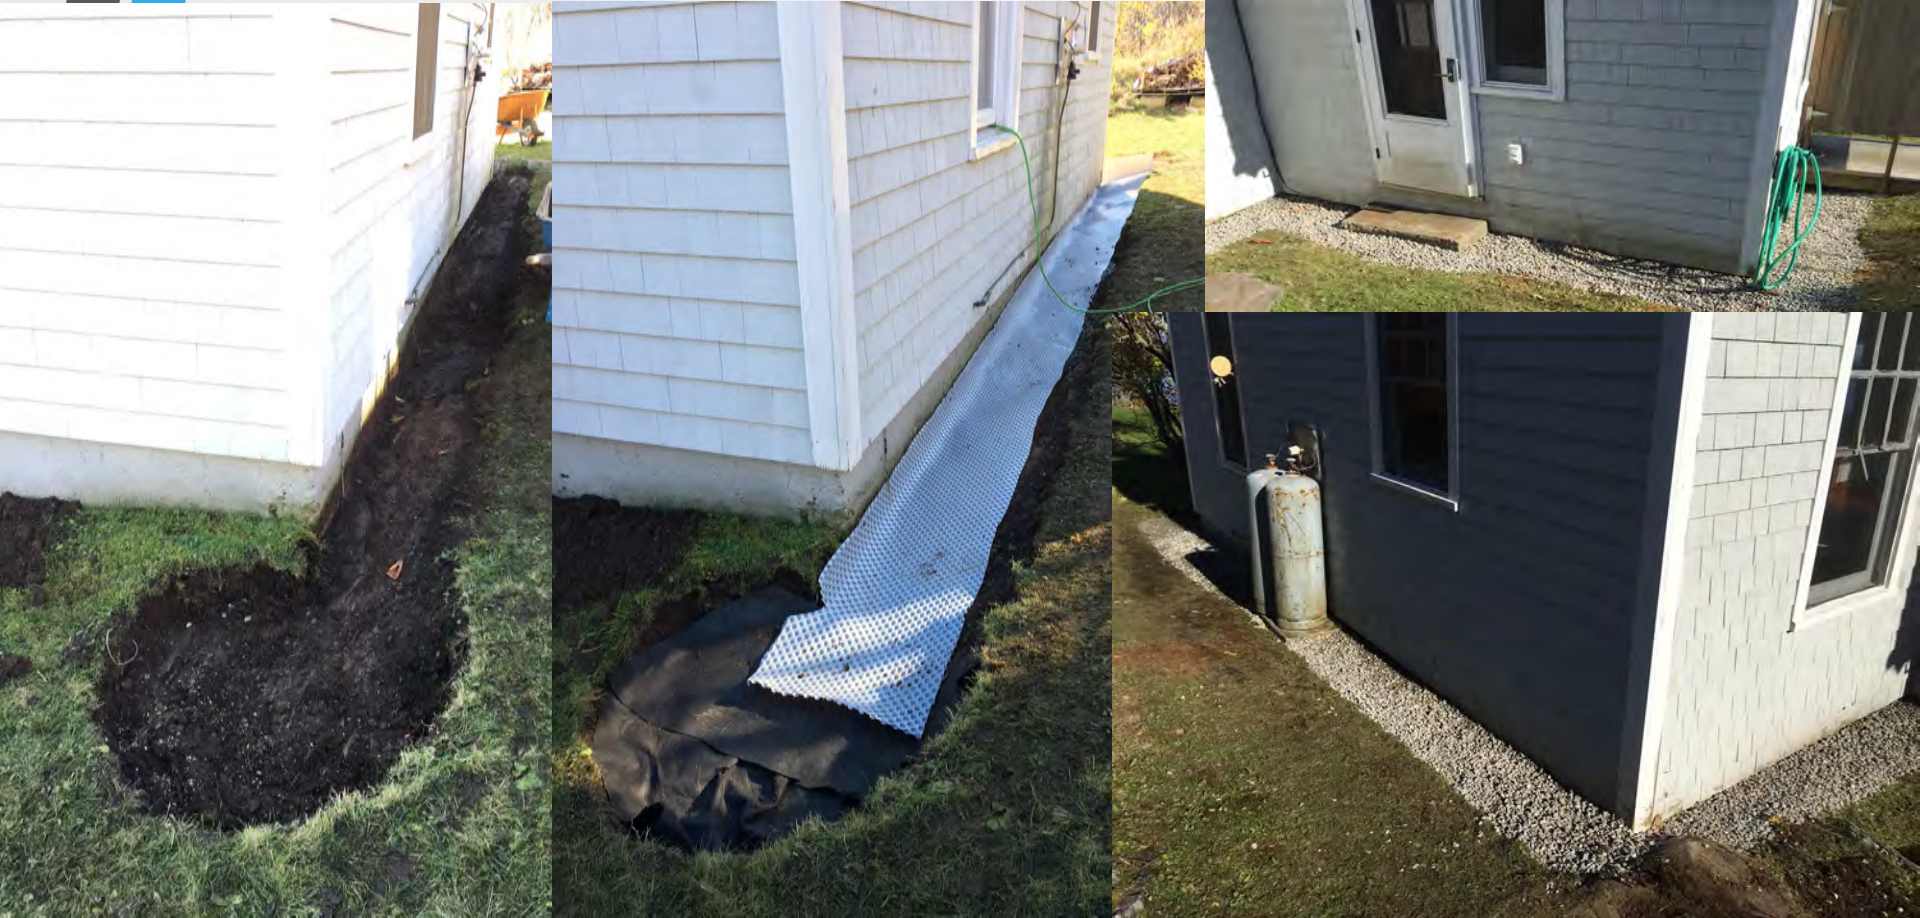
**First step – direct roof water away from the foundation walls**

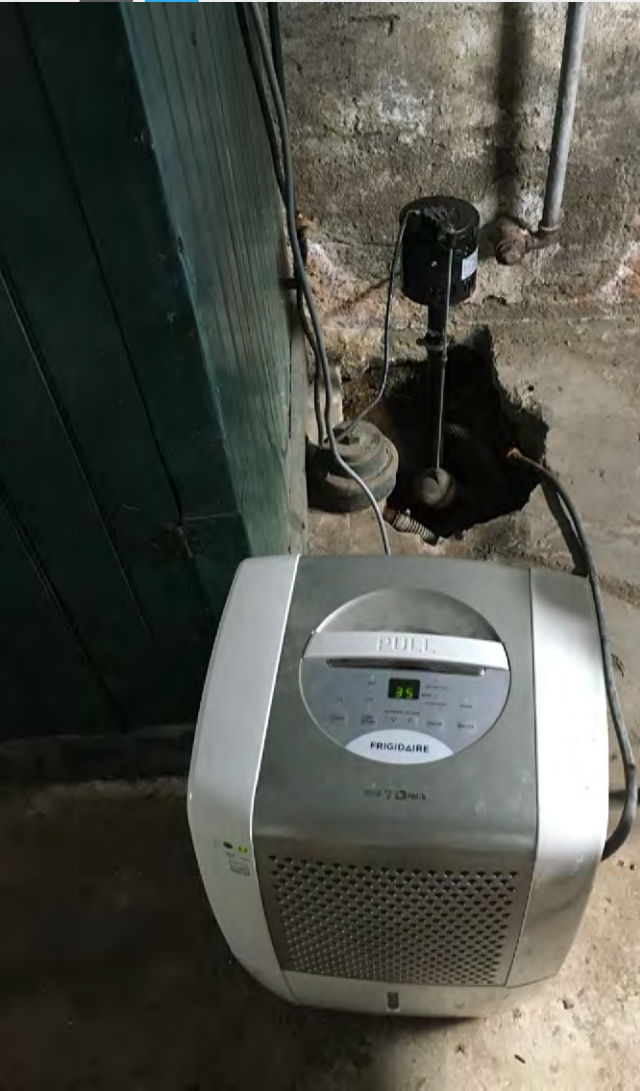
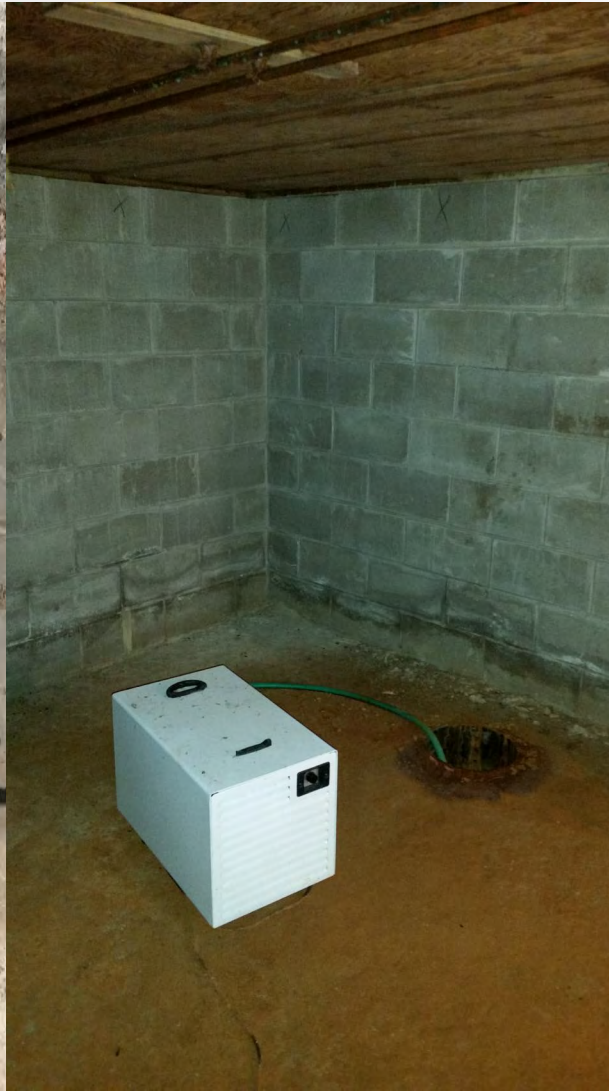
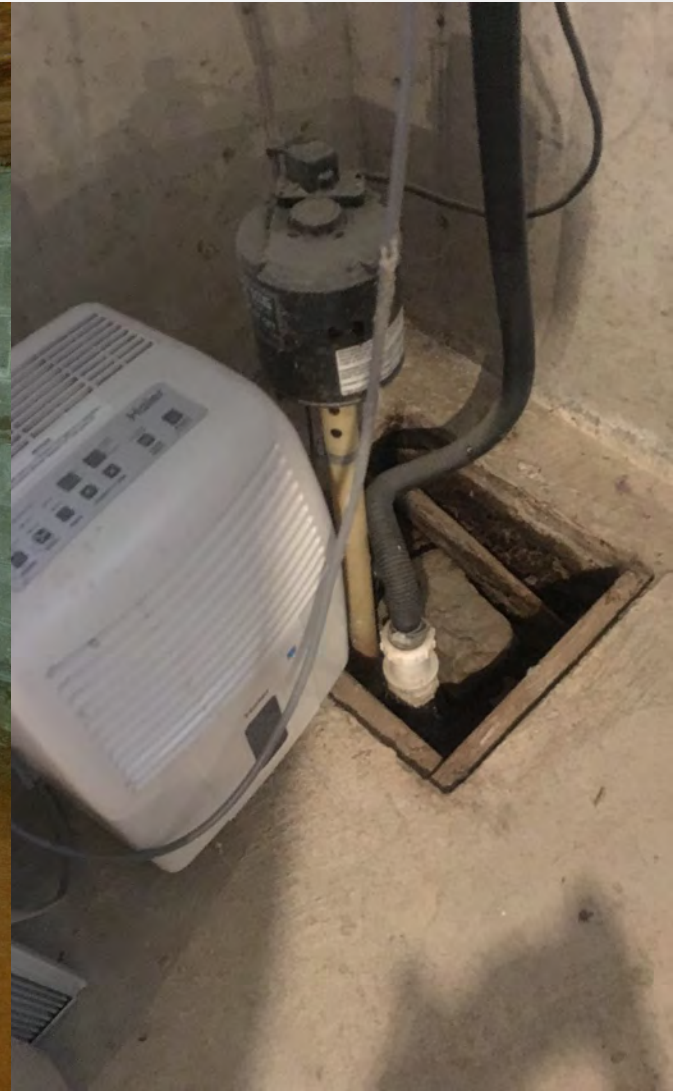
**Avoid “Circular” Dehumidification**

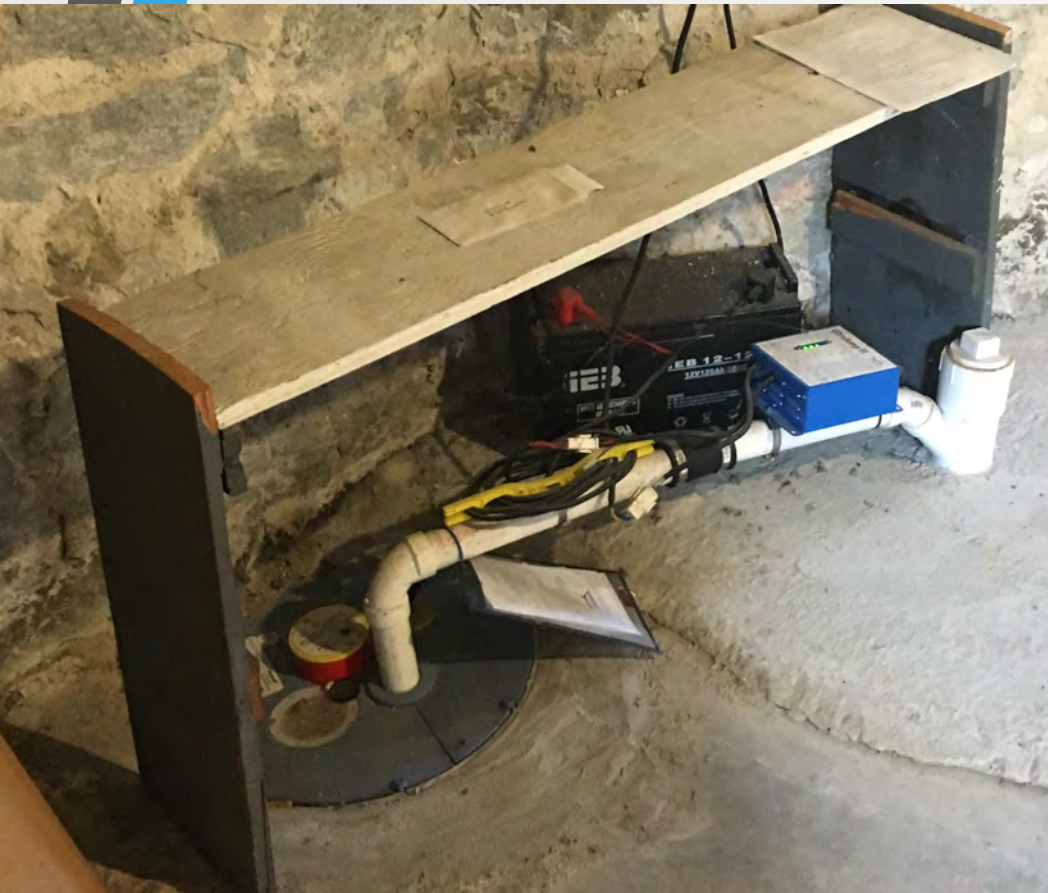
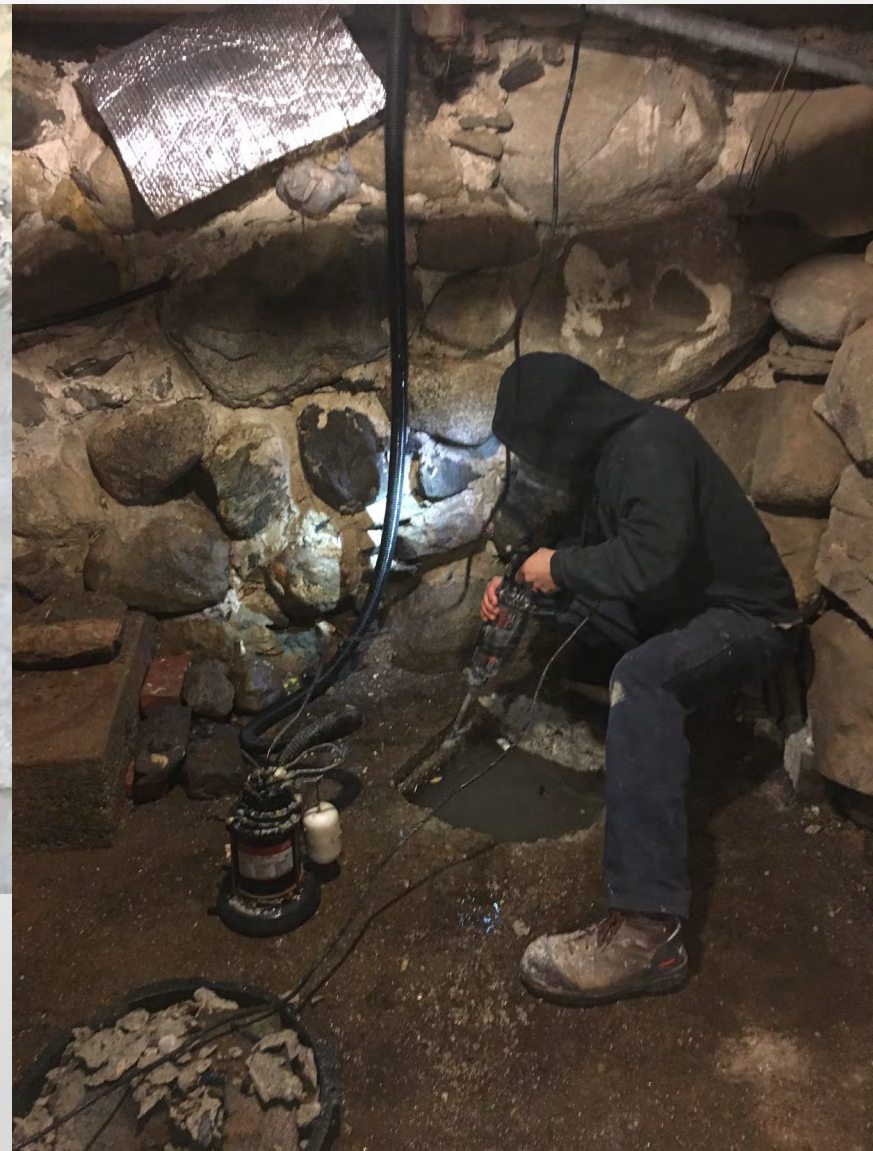
**Sealed Sump Basins  
Should Be Installed**

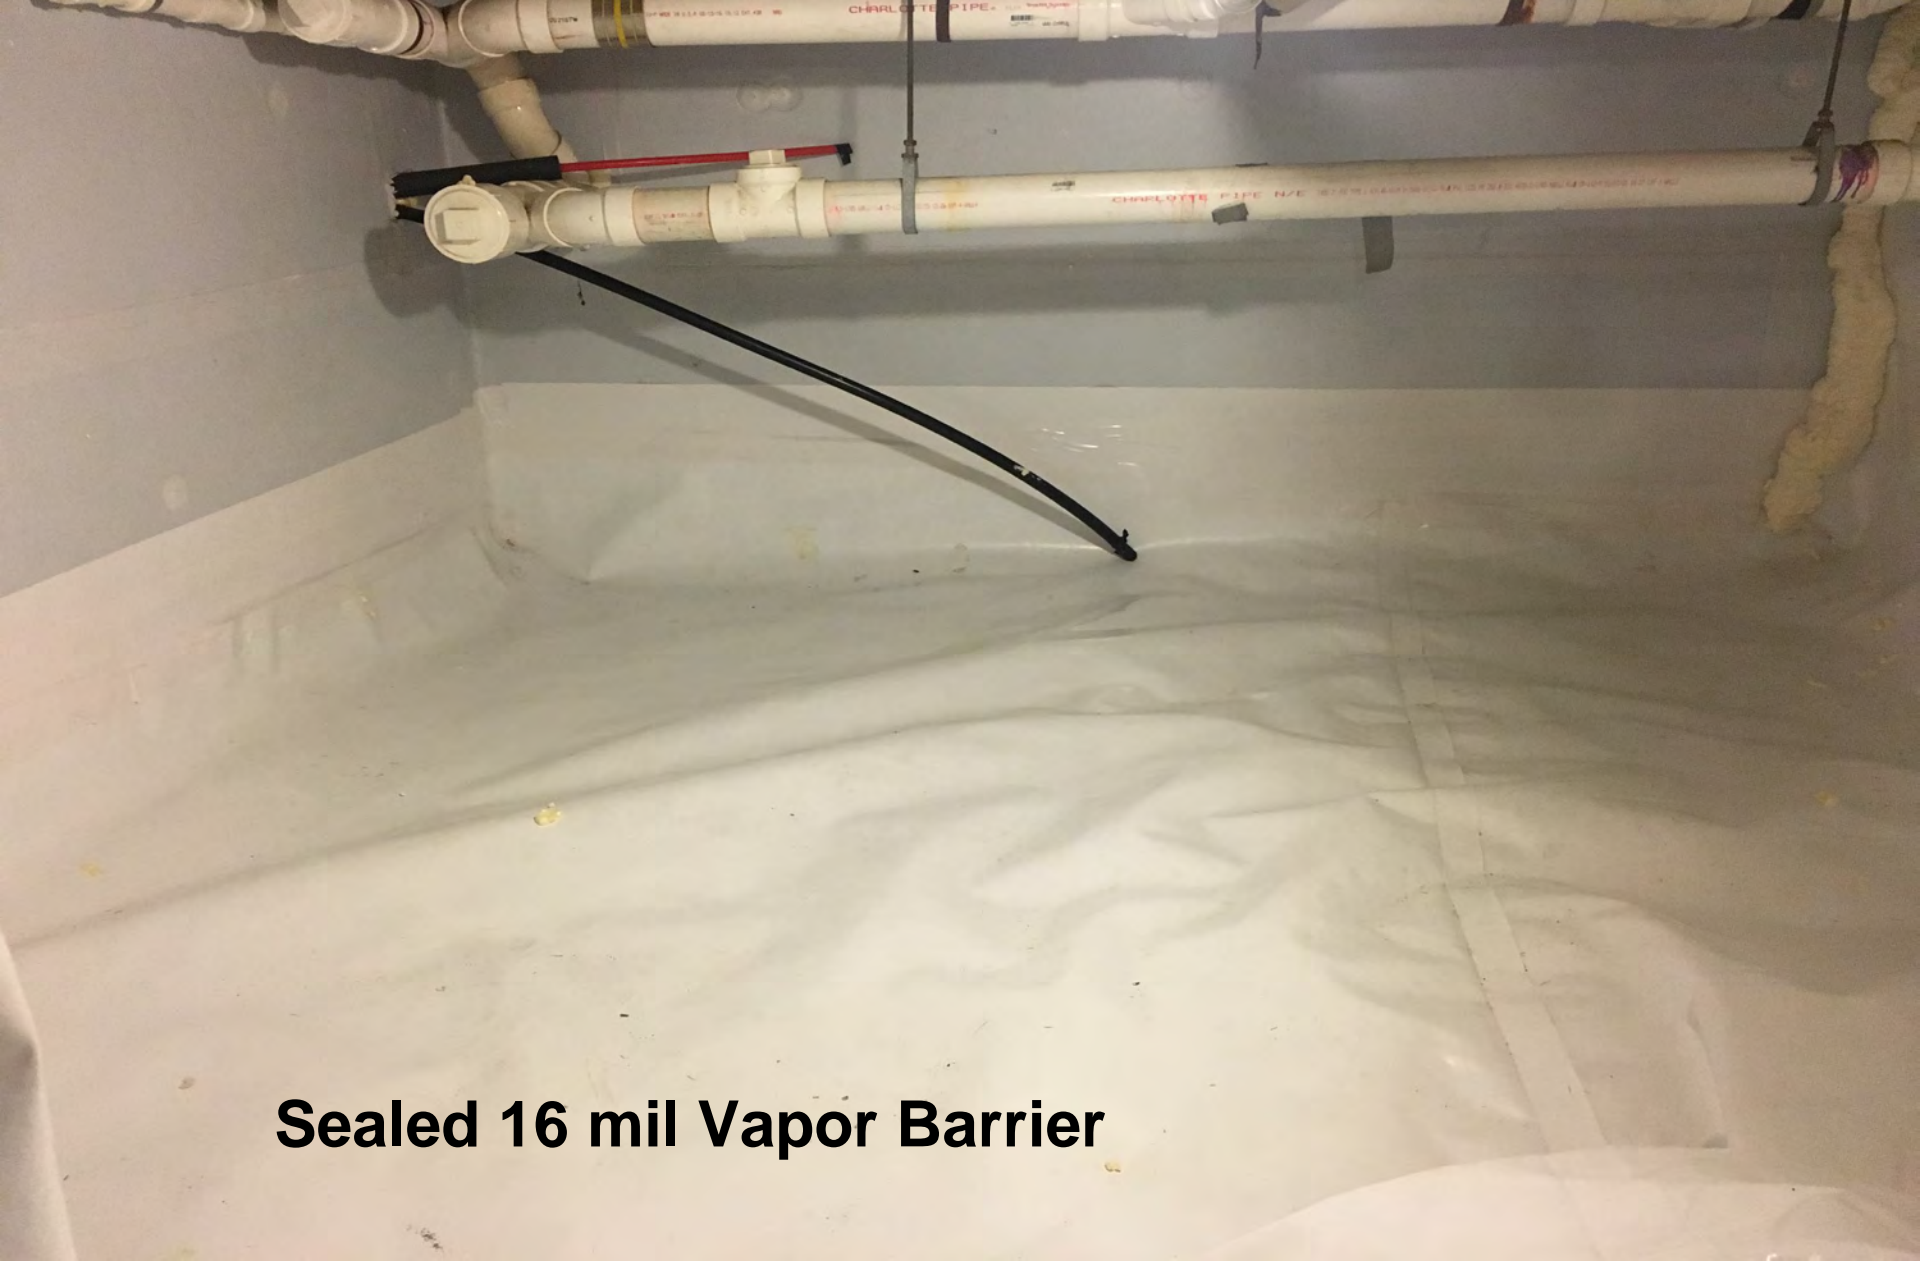
**Sealed 16 mil Vapor Barrier**

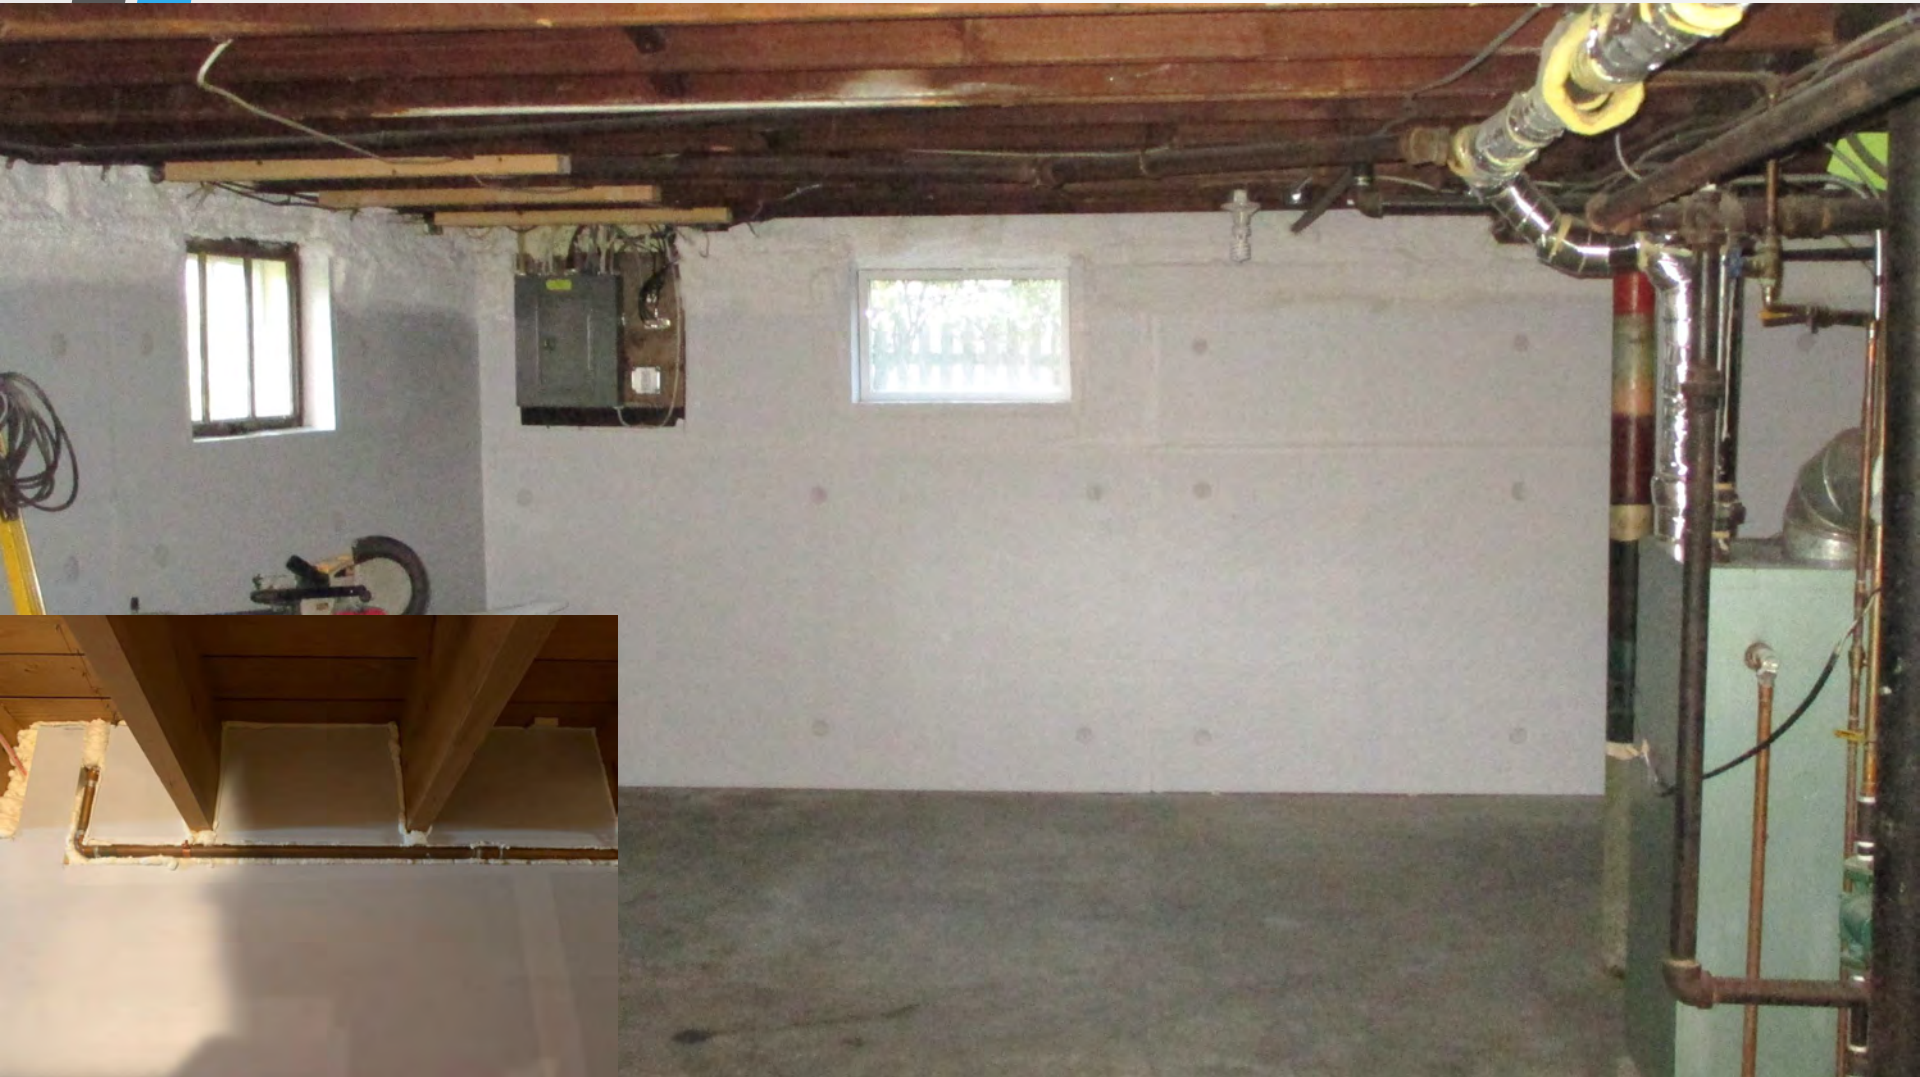
**2" White Faced Thermax Rigid Foam Board, R-13**

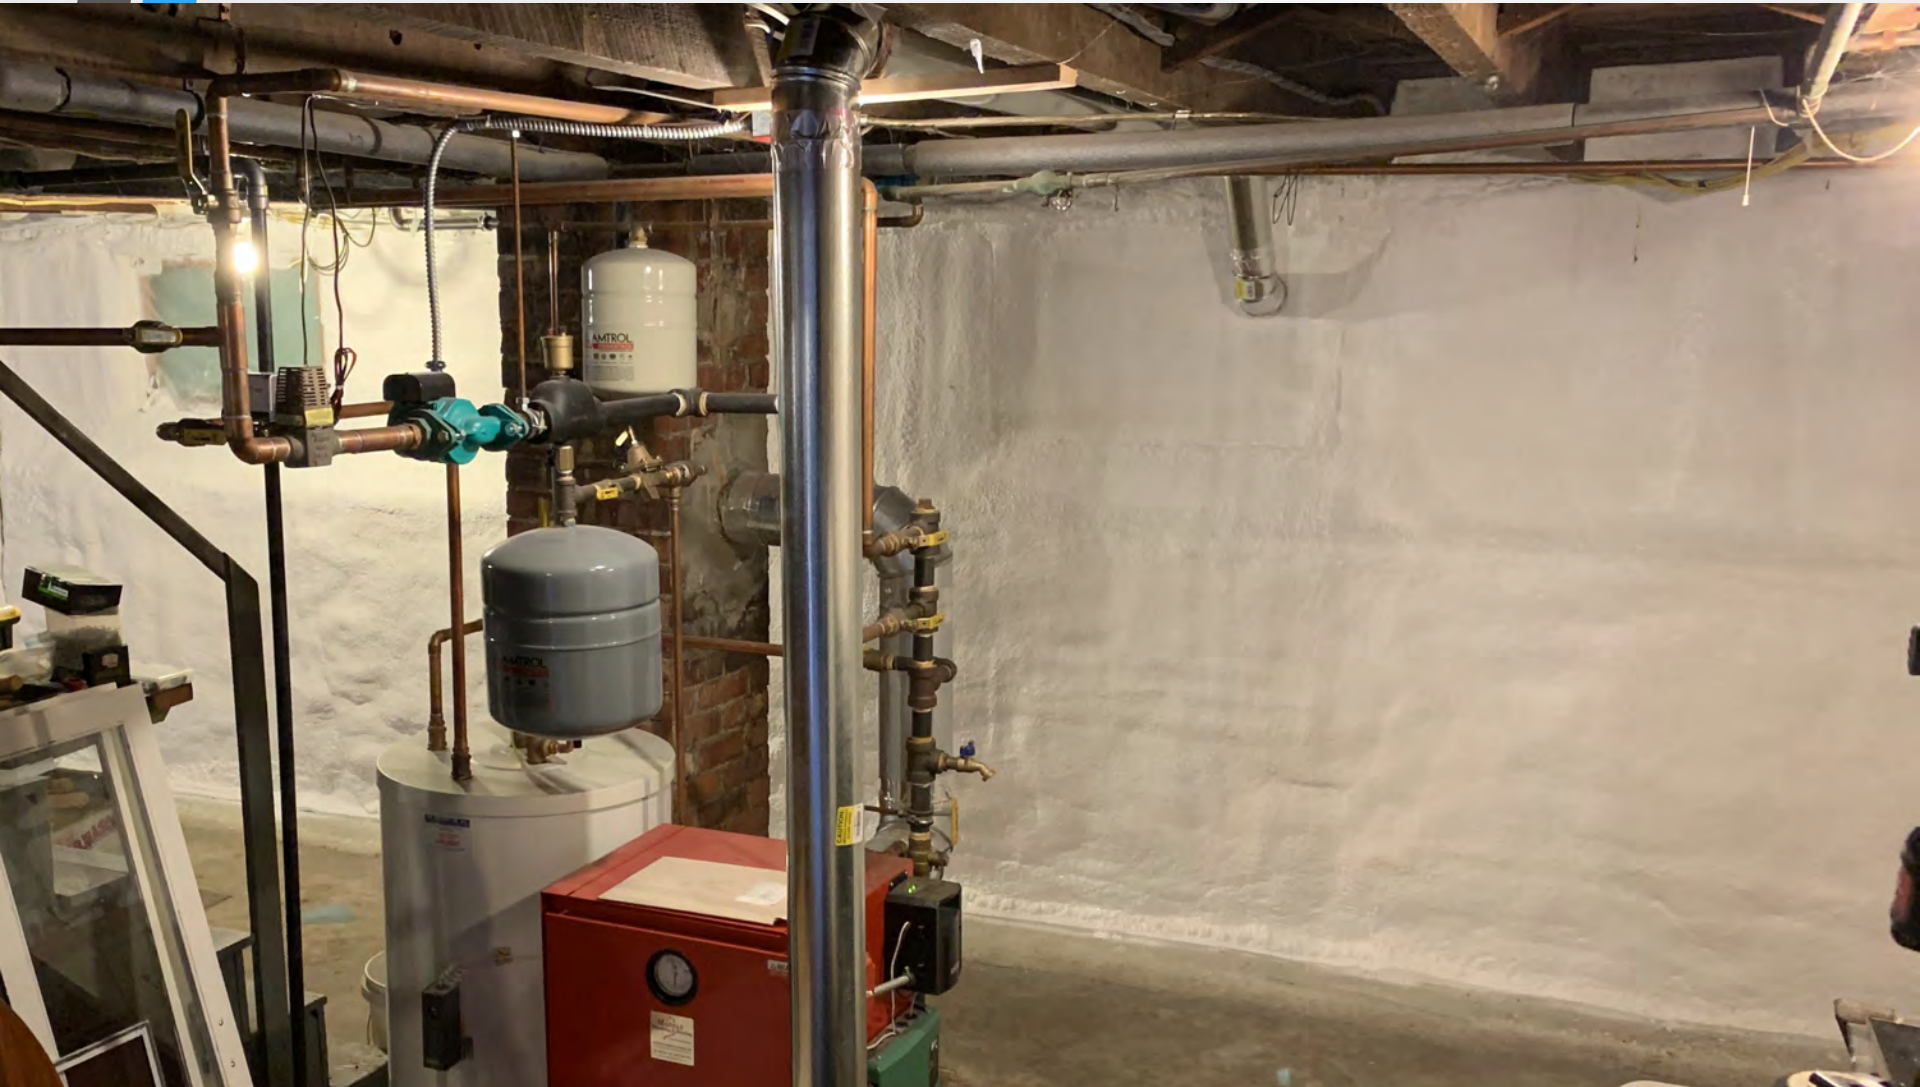
**2" Closed Cell Spray Foam with Thermal Barrier, R-13**

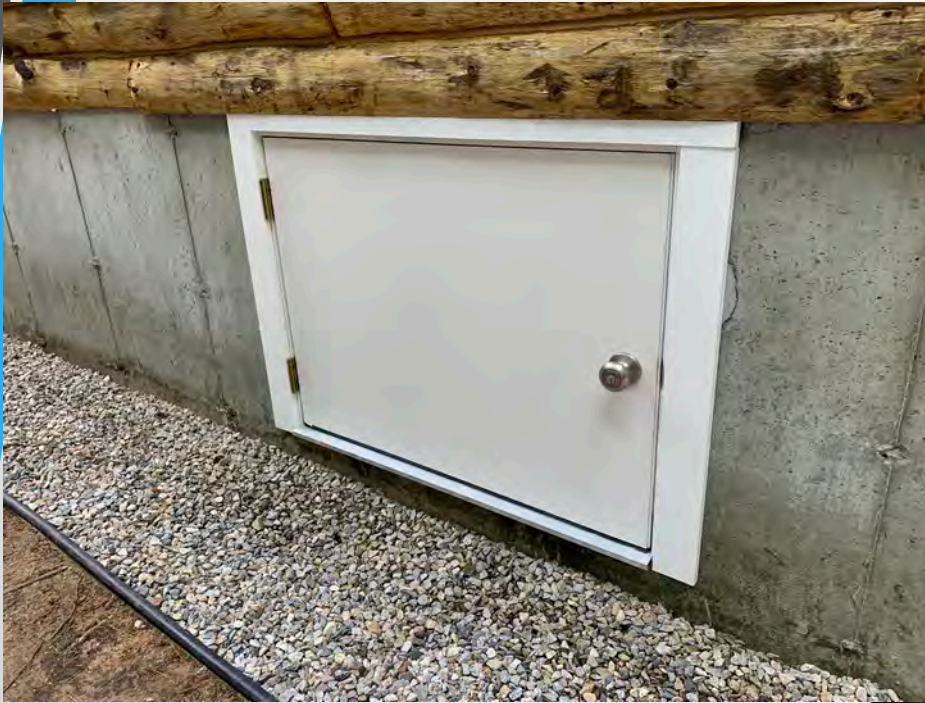
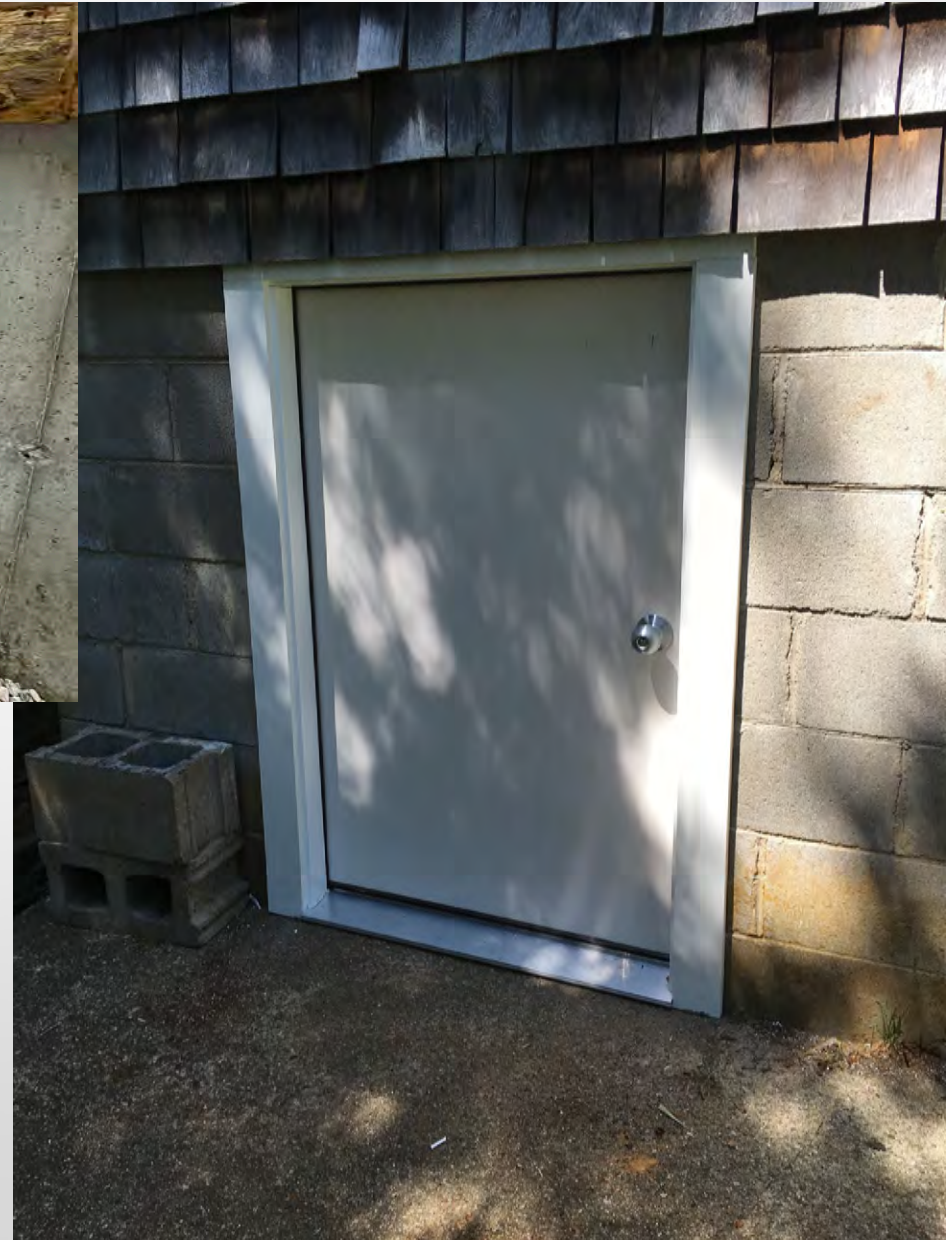
**Therma-Tru Smooth-Star**

**Insulated**

**Fiberglass – no rust**

**Composite jamb options**

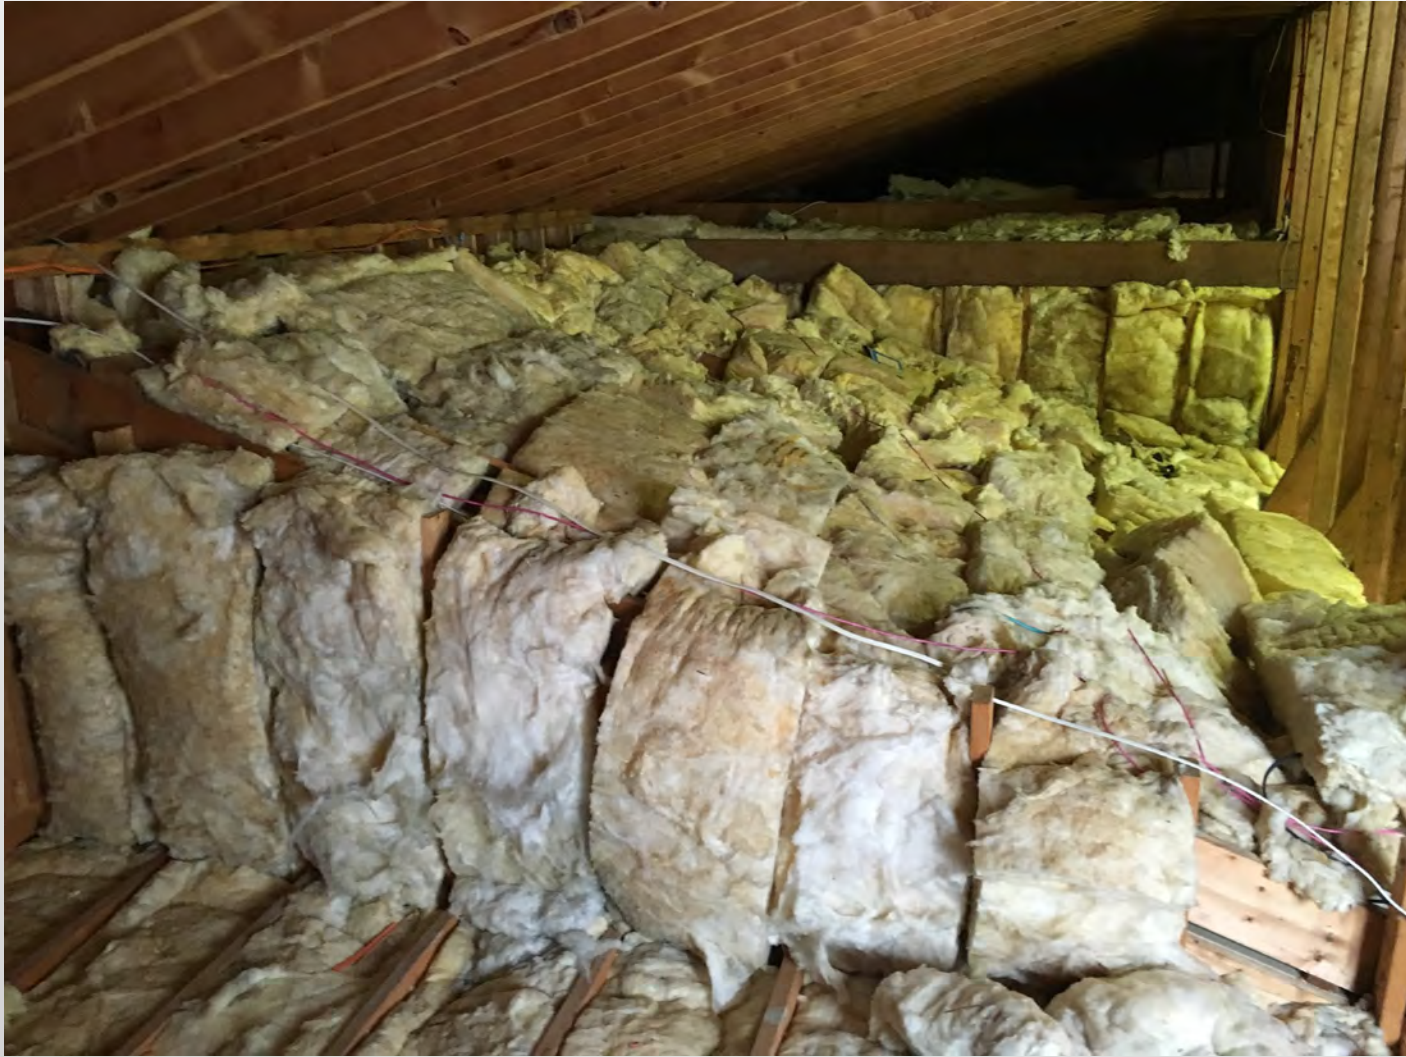
**Fiberglass does not effectively stop air movement (heat loss).**

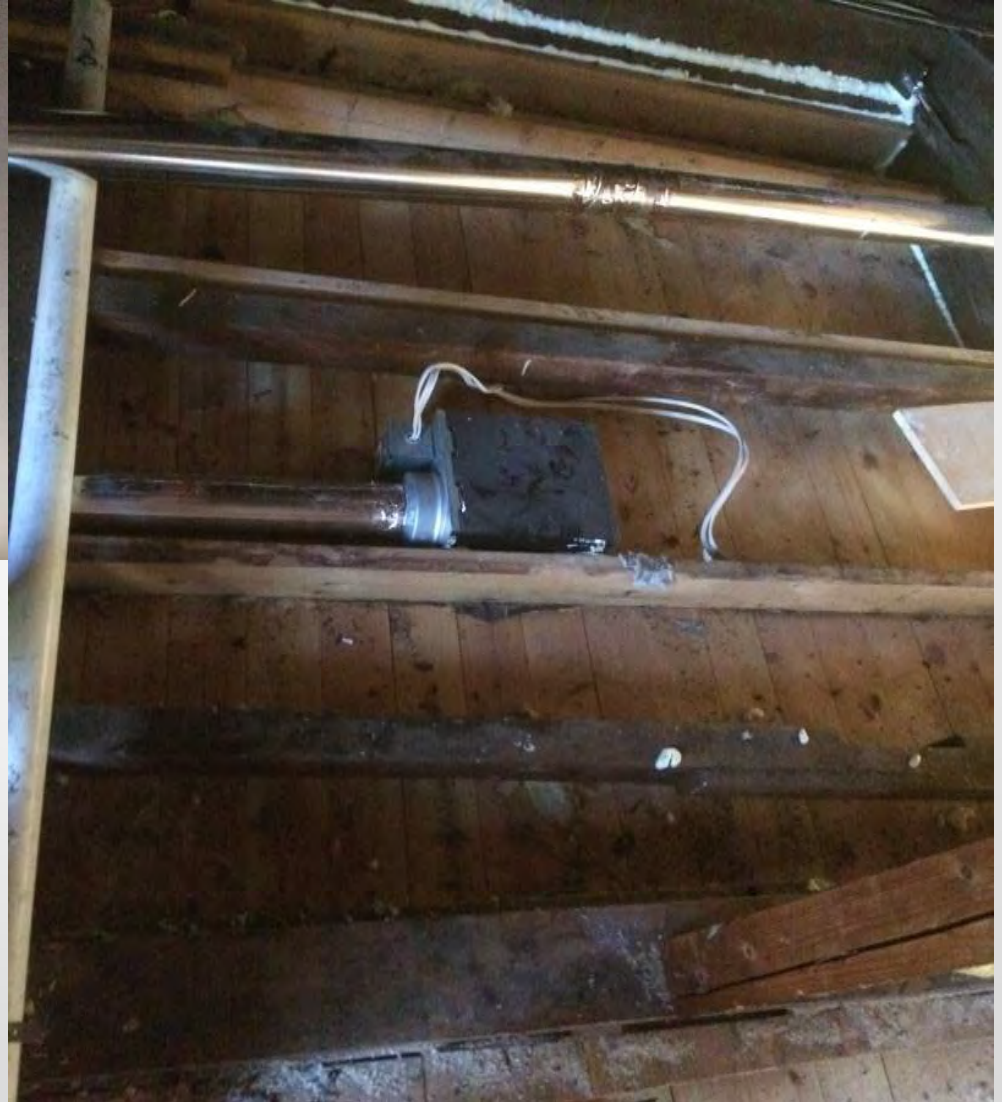
**May require an electrician**

**Should be ducted to the  
closest gable end wall, if  
possible**

**Use rigid metal ductwork,  
sealed with mastic**

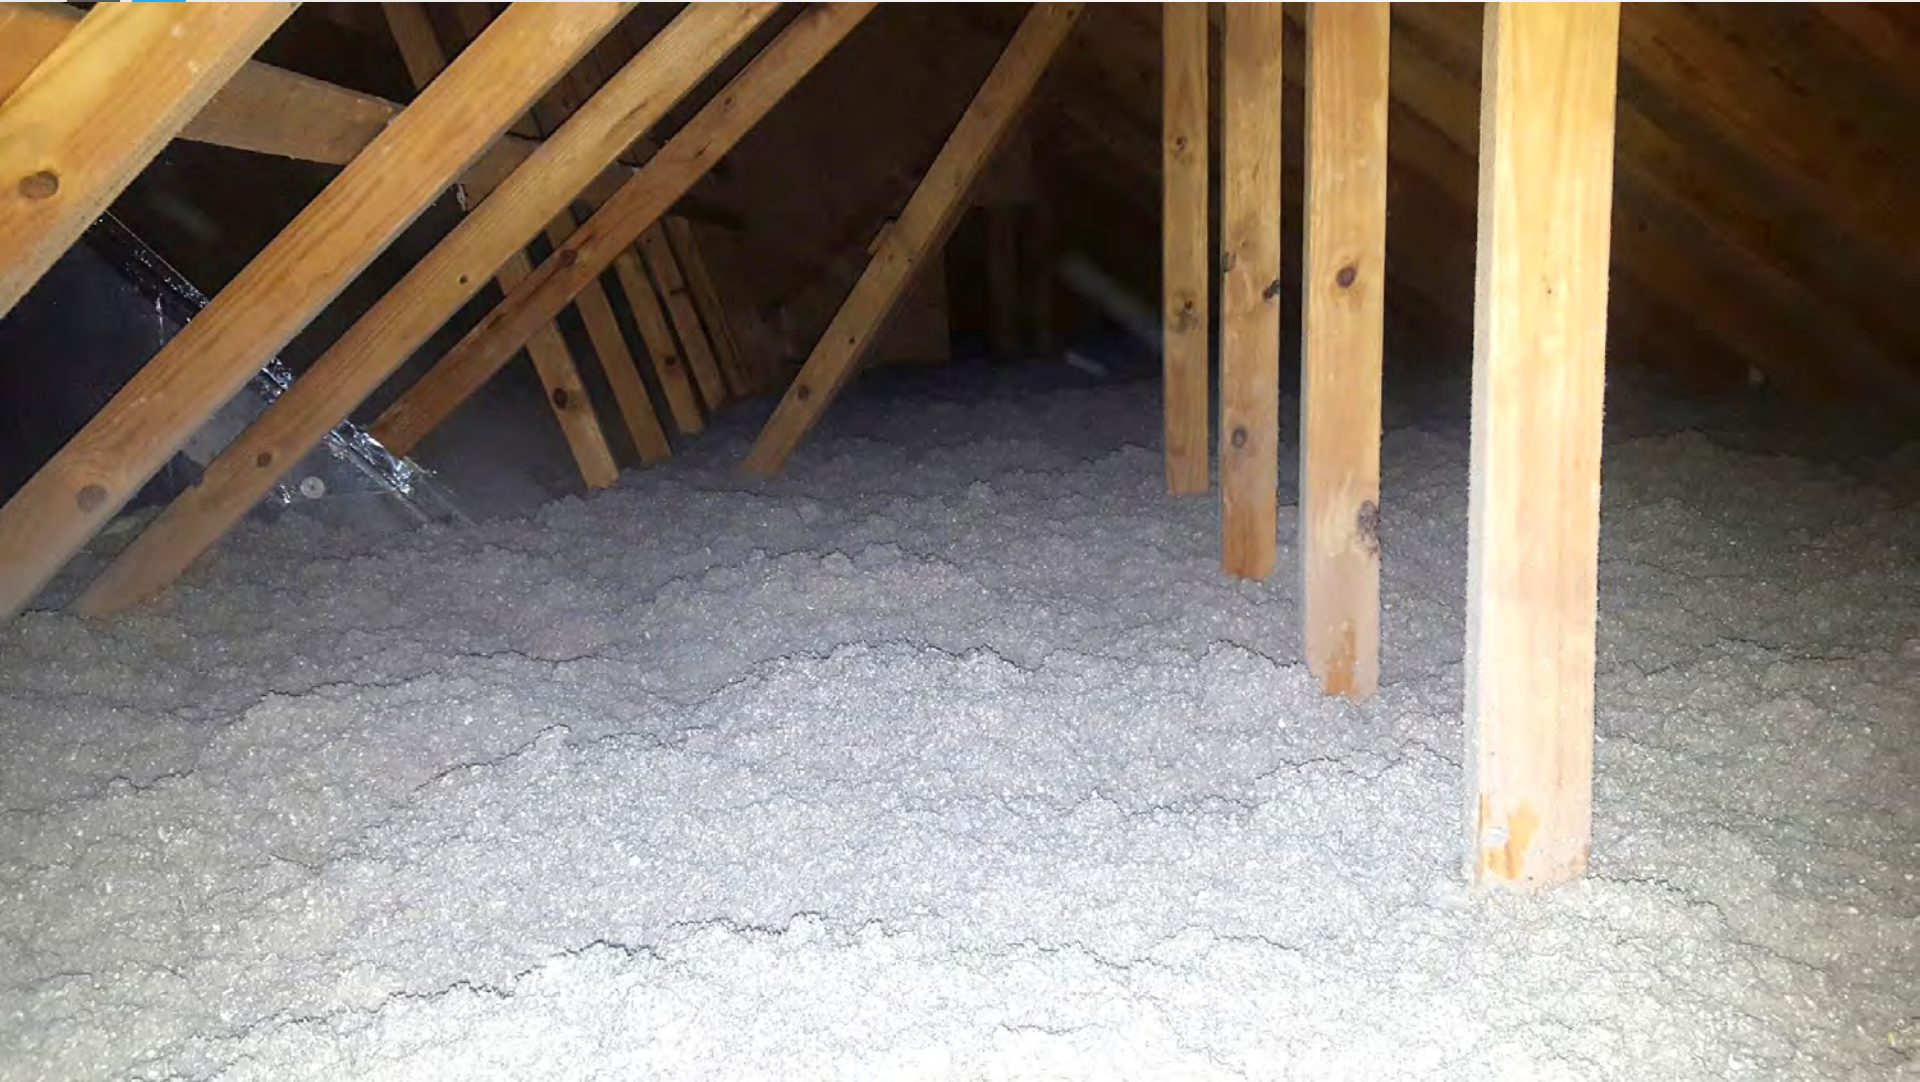
**16" Loose Fill Cellulose, R-49**
