# **Weatherization is Sexy**

**Claire Betze & Jon Riley**

# Case Study

# Island Farm House

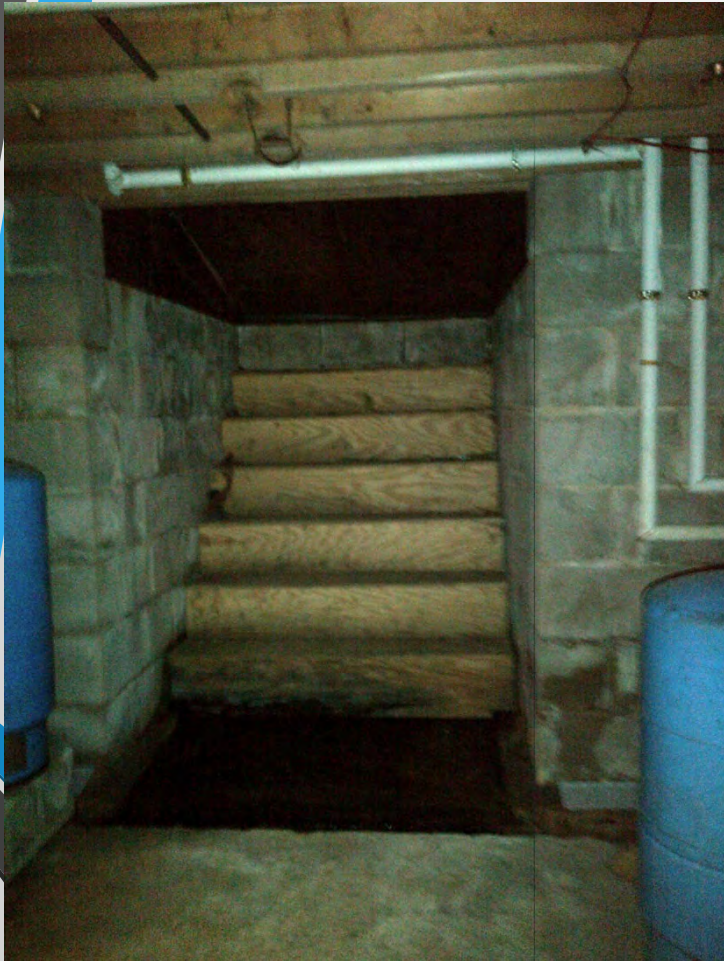
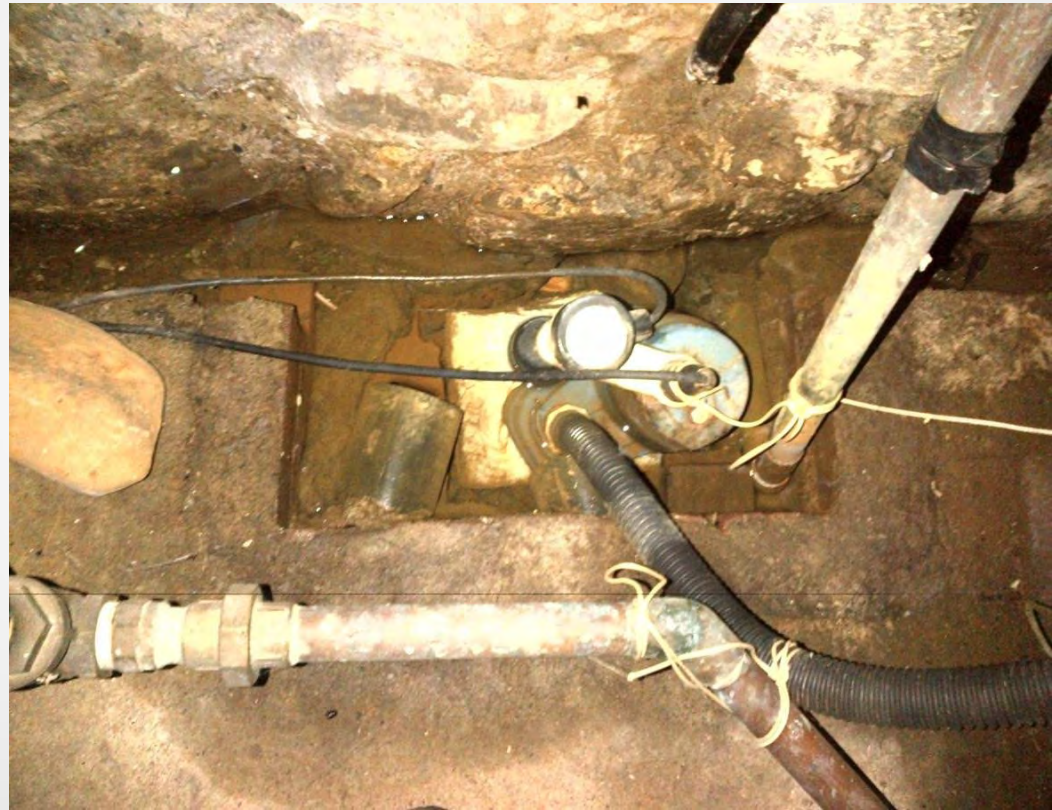
**Wet Conditions**

**Open Sump**

**Wet and Wide Open Bulkhead**

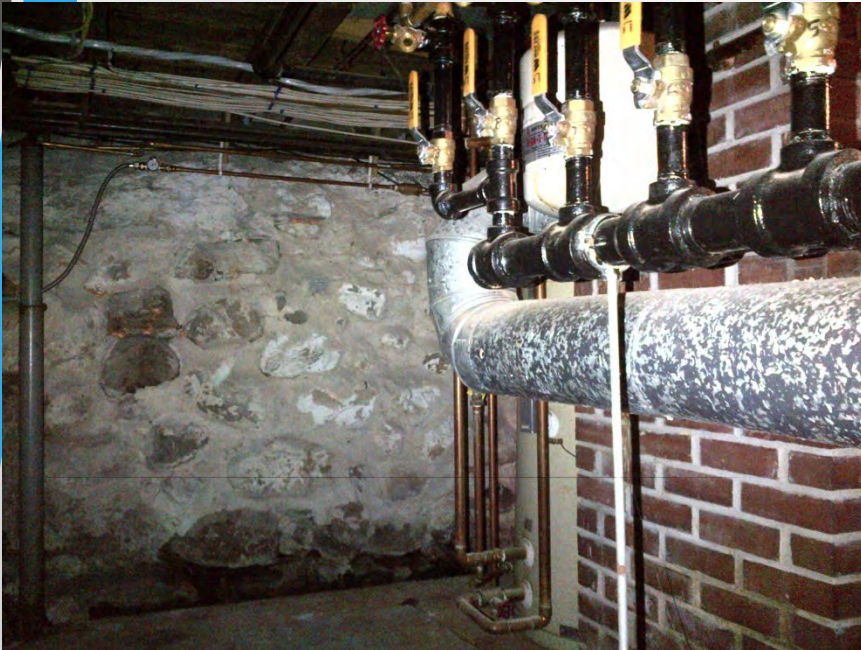
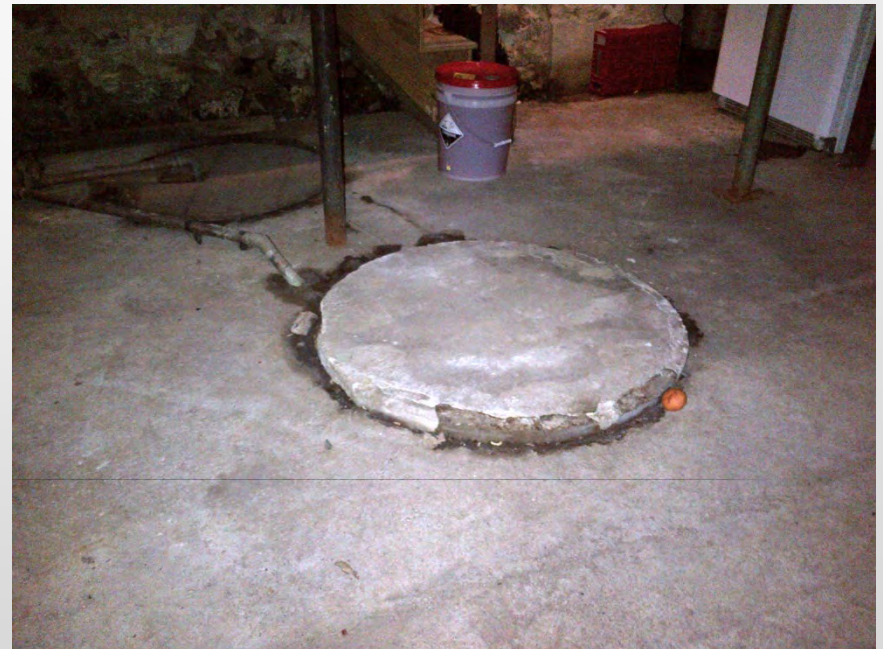
**Seepage at base of foundation**

**Old cistern**

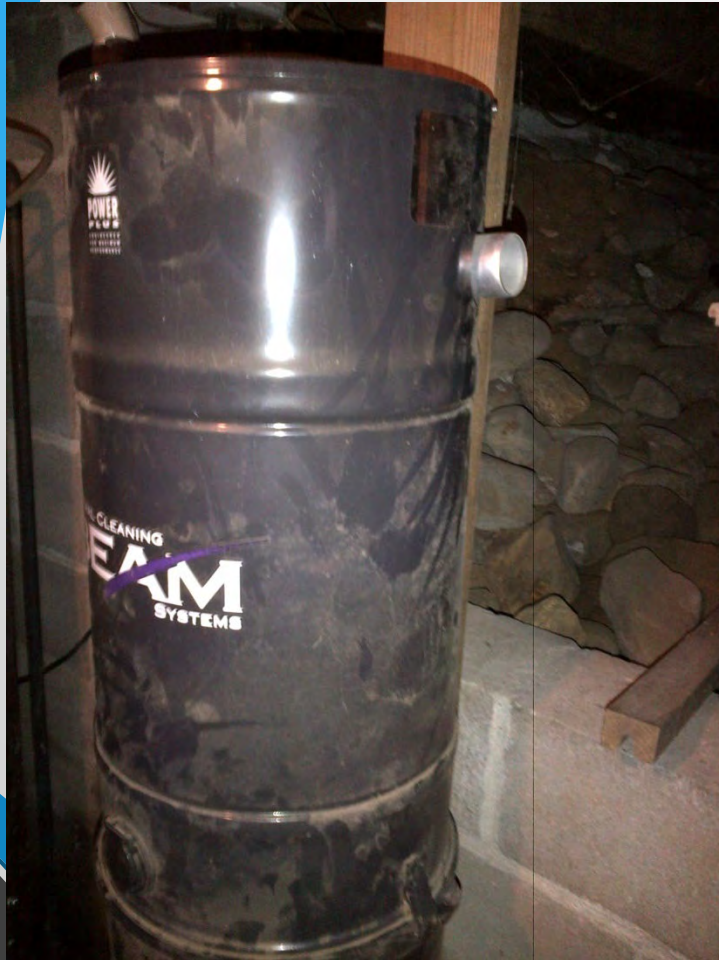
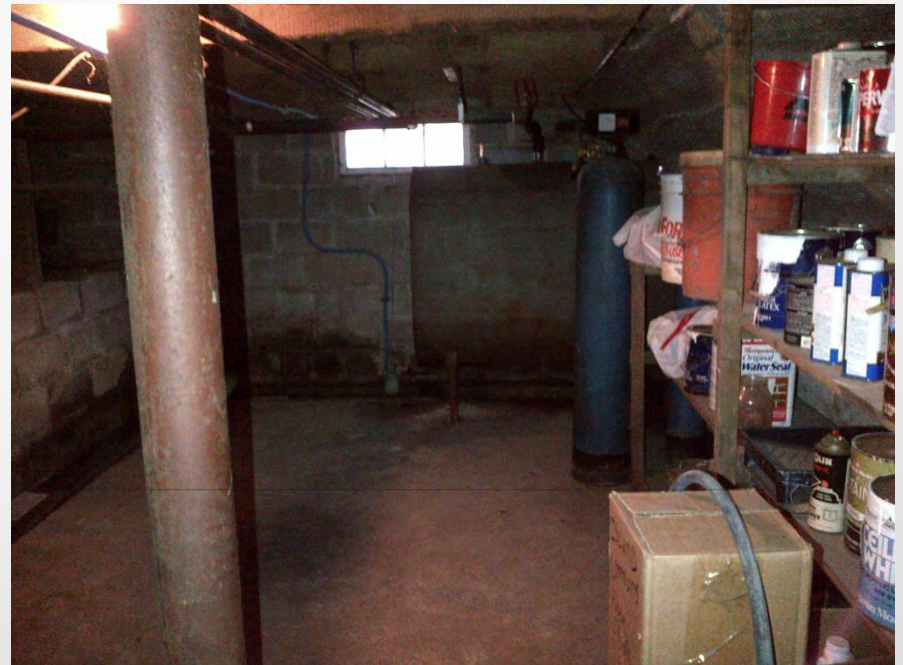
**Unvented central vacuum  
Moisture impact to oil tank**

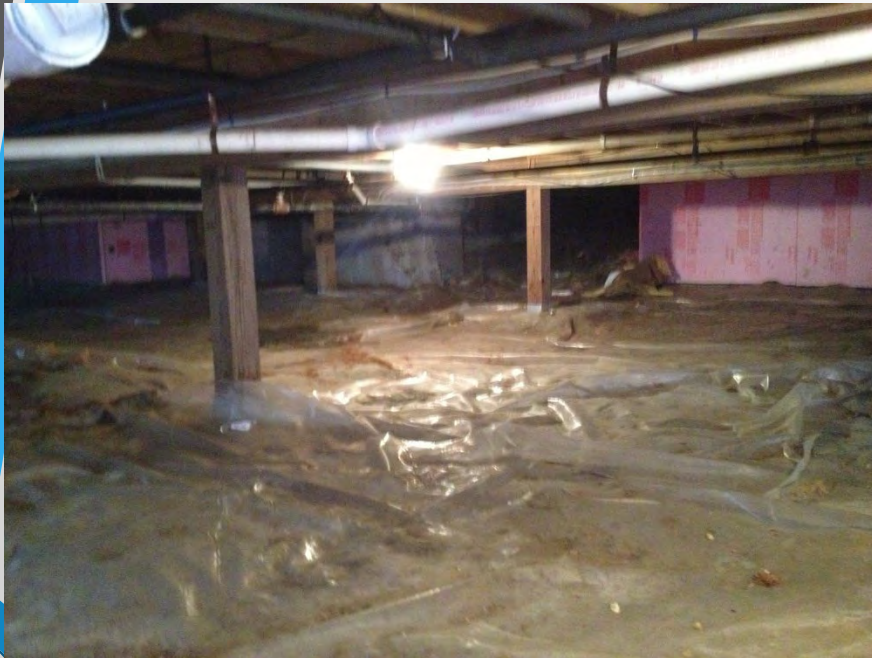
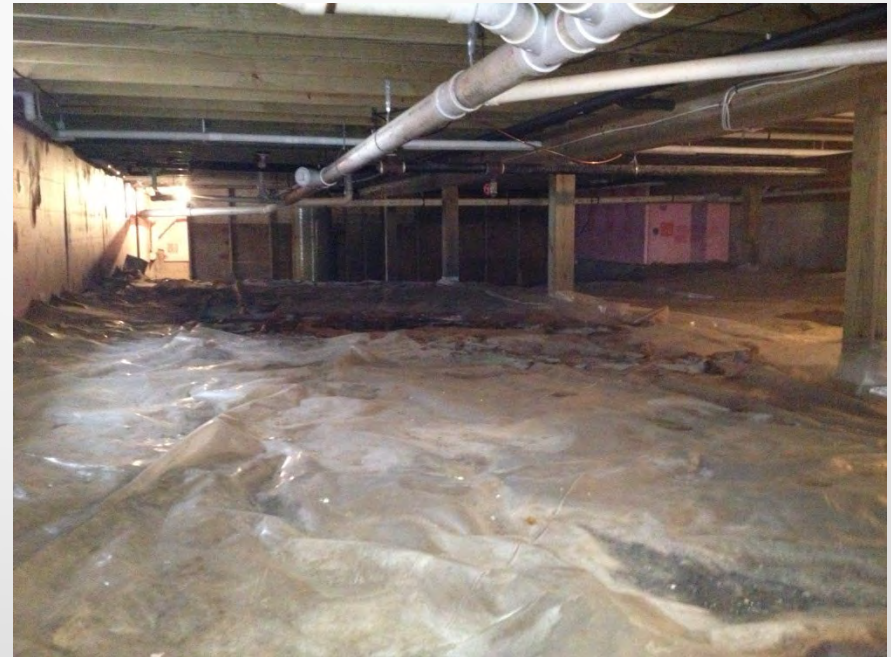
**Damp, Musty Conditions**

**Unsealed poly vapor barrier, rigid foam on foundation walls**

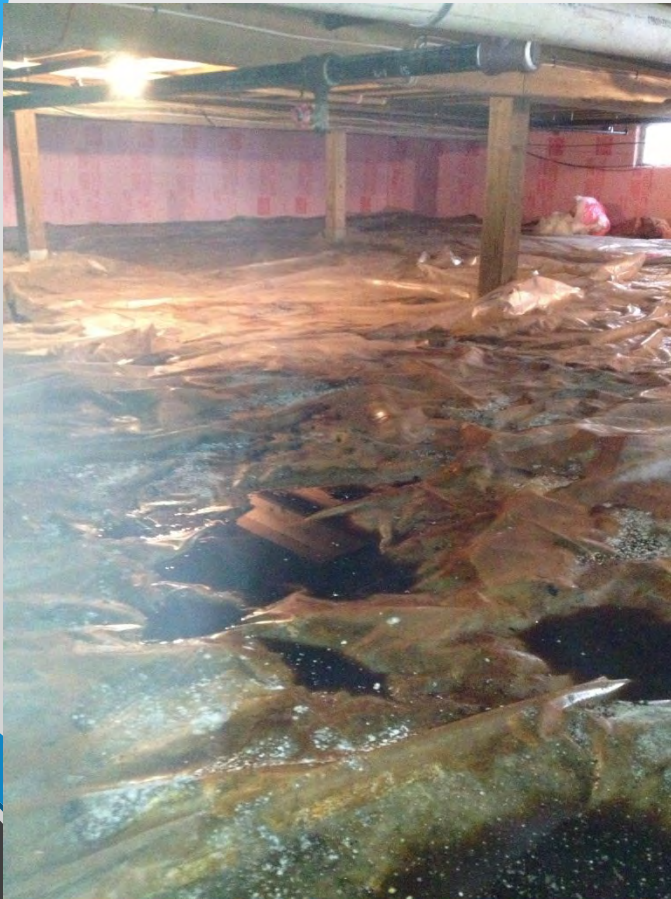
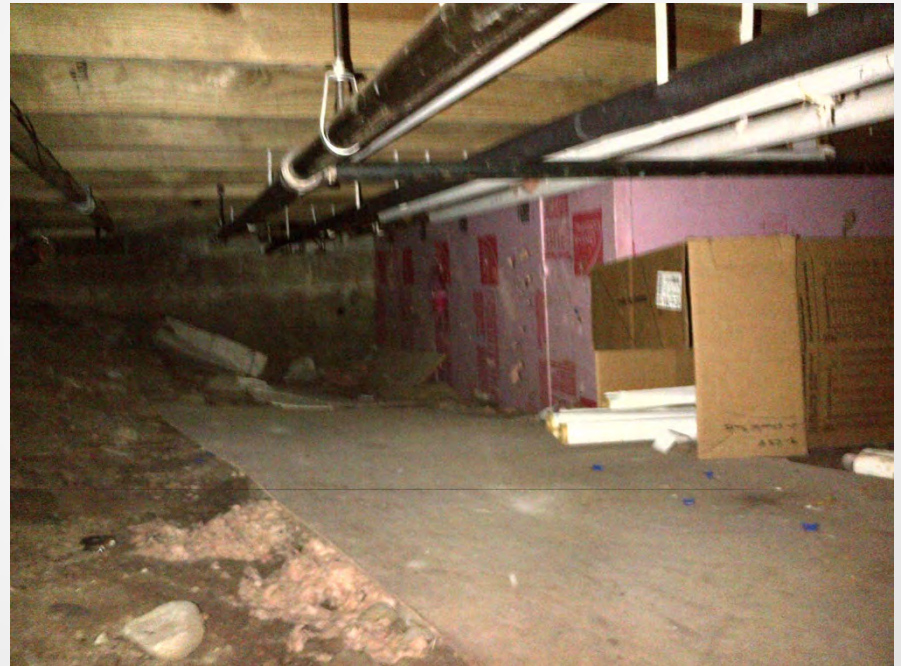
**Leaking pipes**

**Incomplete & unsealed vapor barrier**

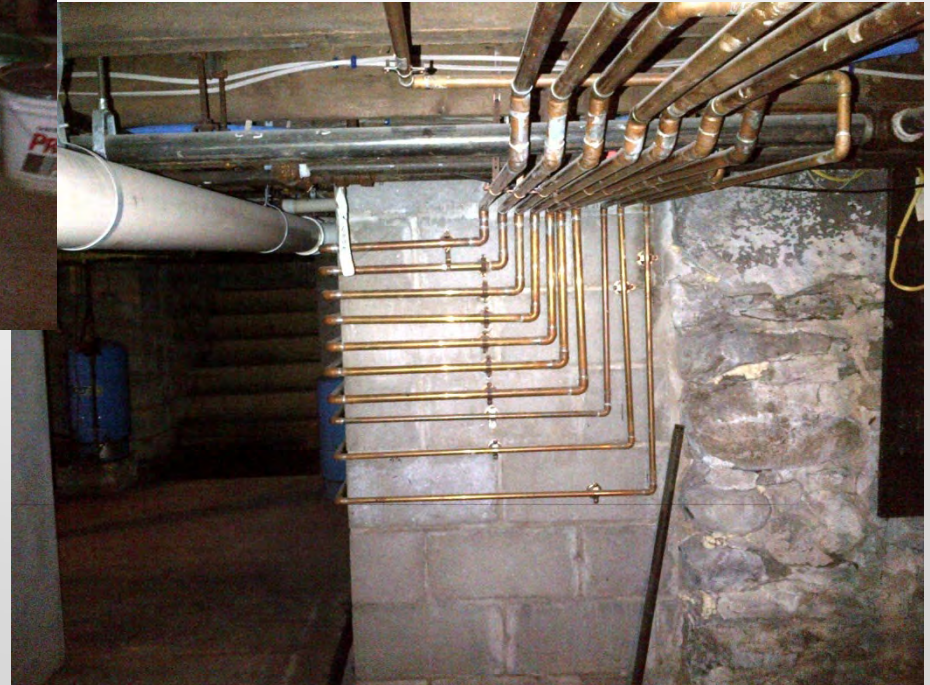
**Oil-fired boiler**

**Hot water distribution pipes  
attached directly to concrete**

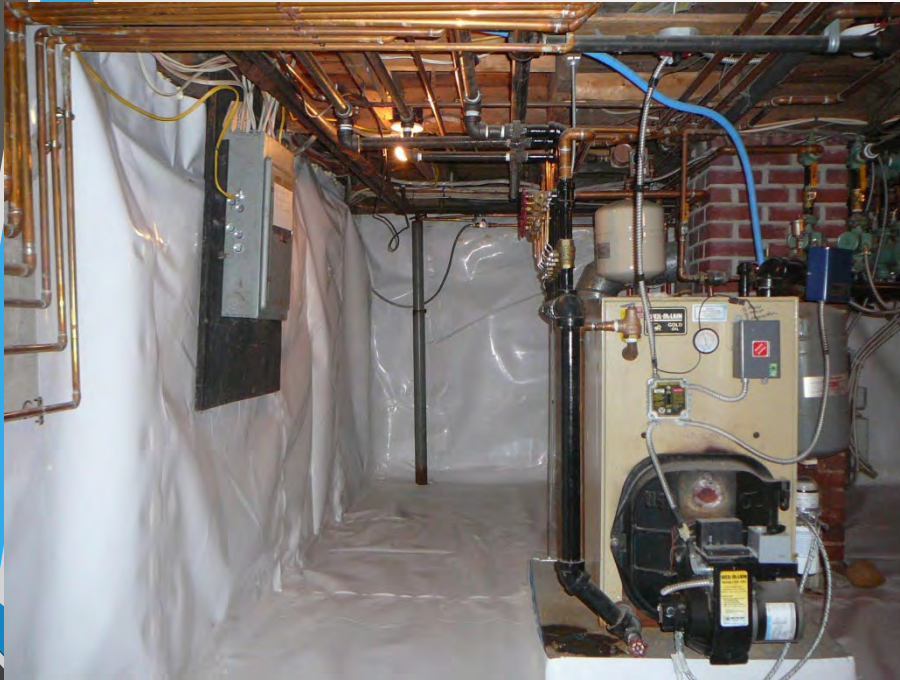
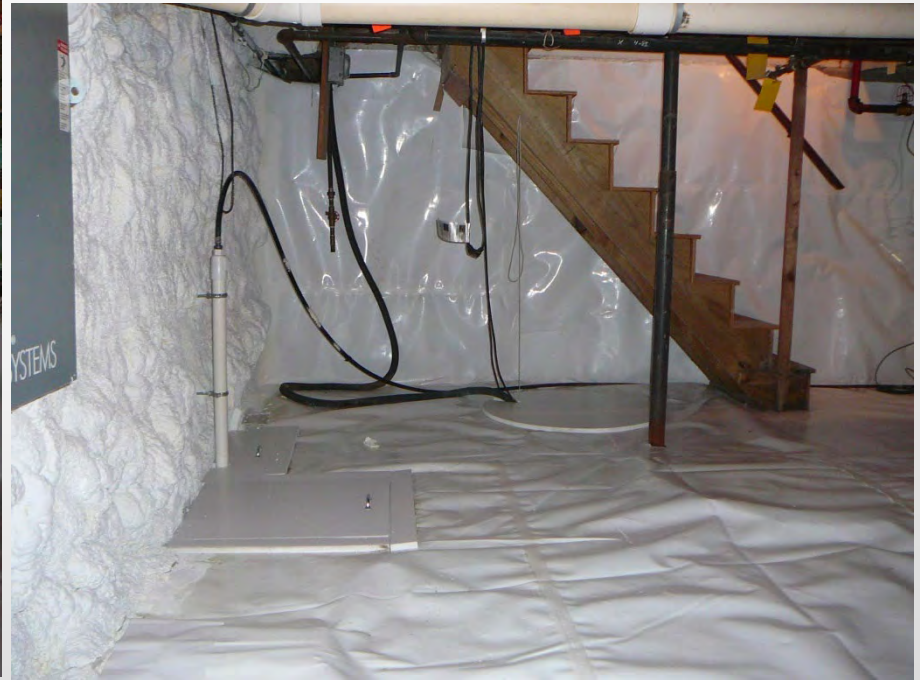
**Vapor barrier and sealed cover over sump**

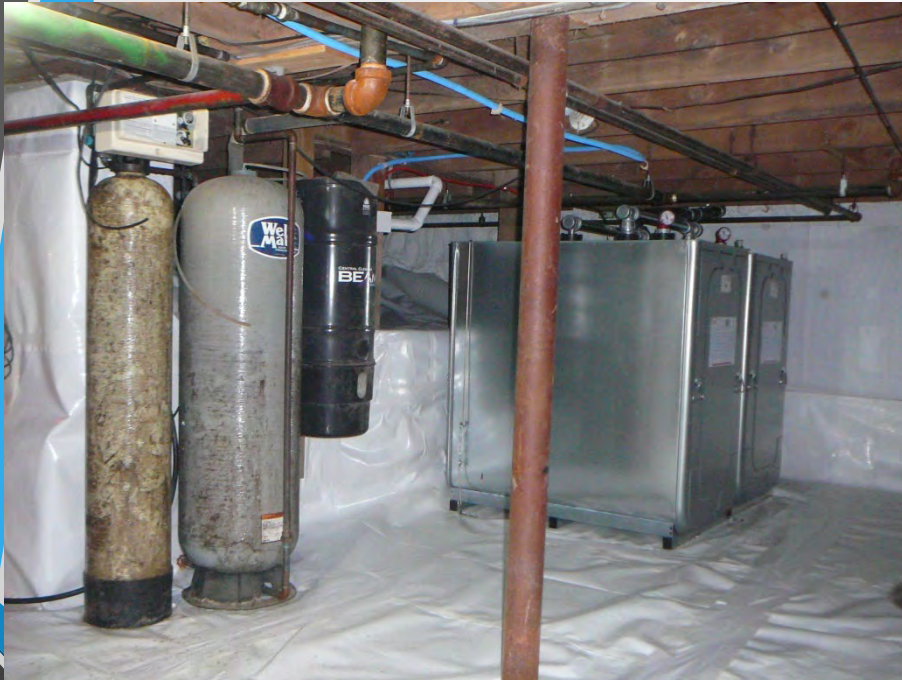
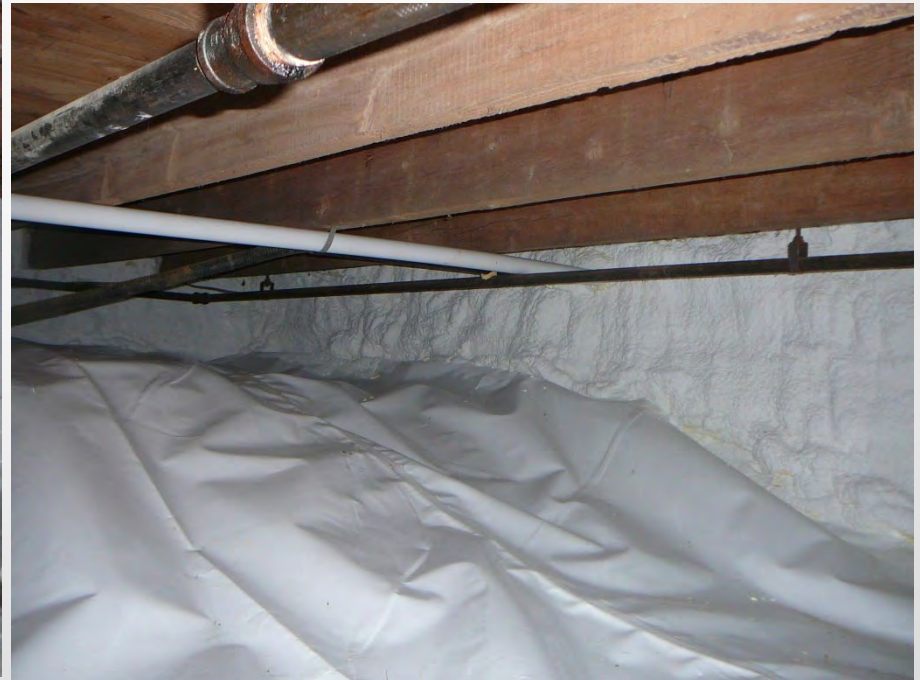
**Central vac exhausted to outside**  
**New double wall oil tanks**

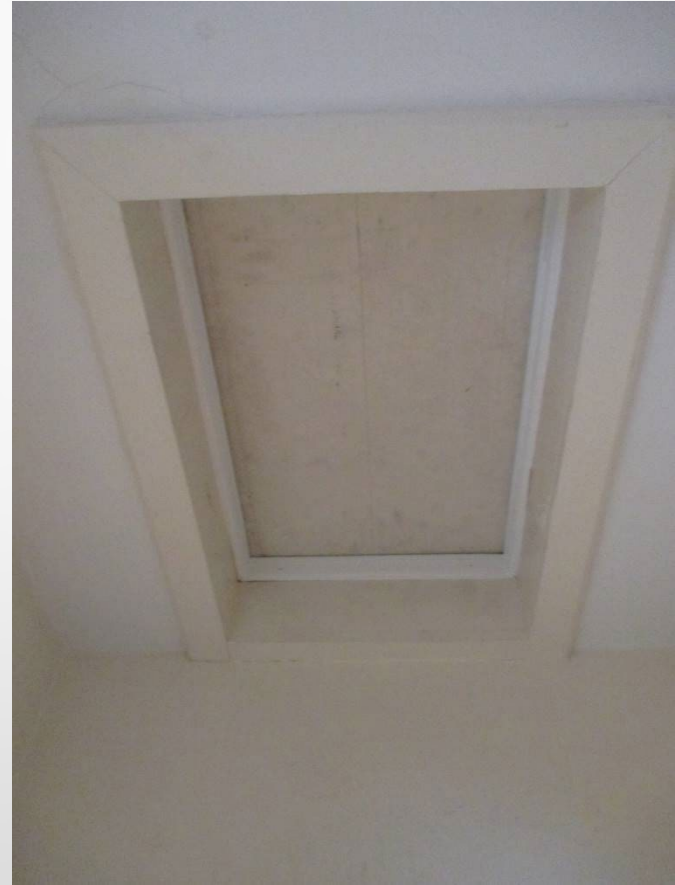
**Insulated, sealed, and weatherstripped hatch cover**
